# Wildlife Lake Habitat Survey Report

**NAME OF LAKE:** Vinge

**DATE OF SURVEY:** 7/6/2009

**Minnesota Department of Natural Resources  
Wildlife Management Section  
Shallow Lakes Program  
Tuesday, December 07, 2010**

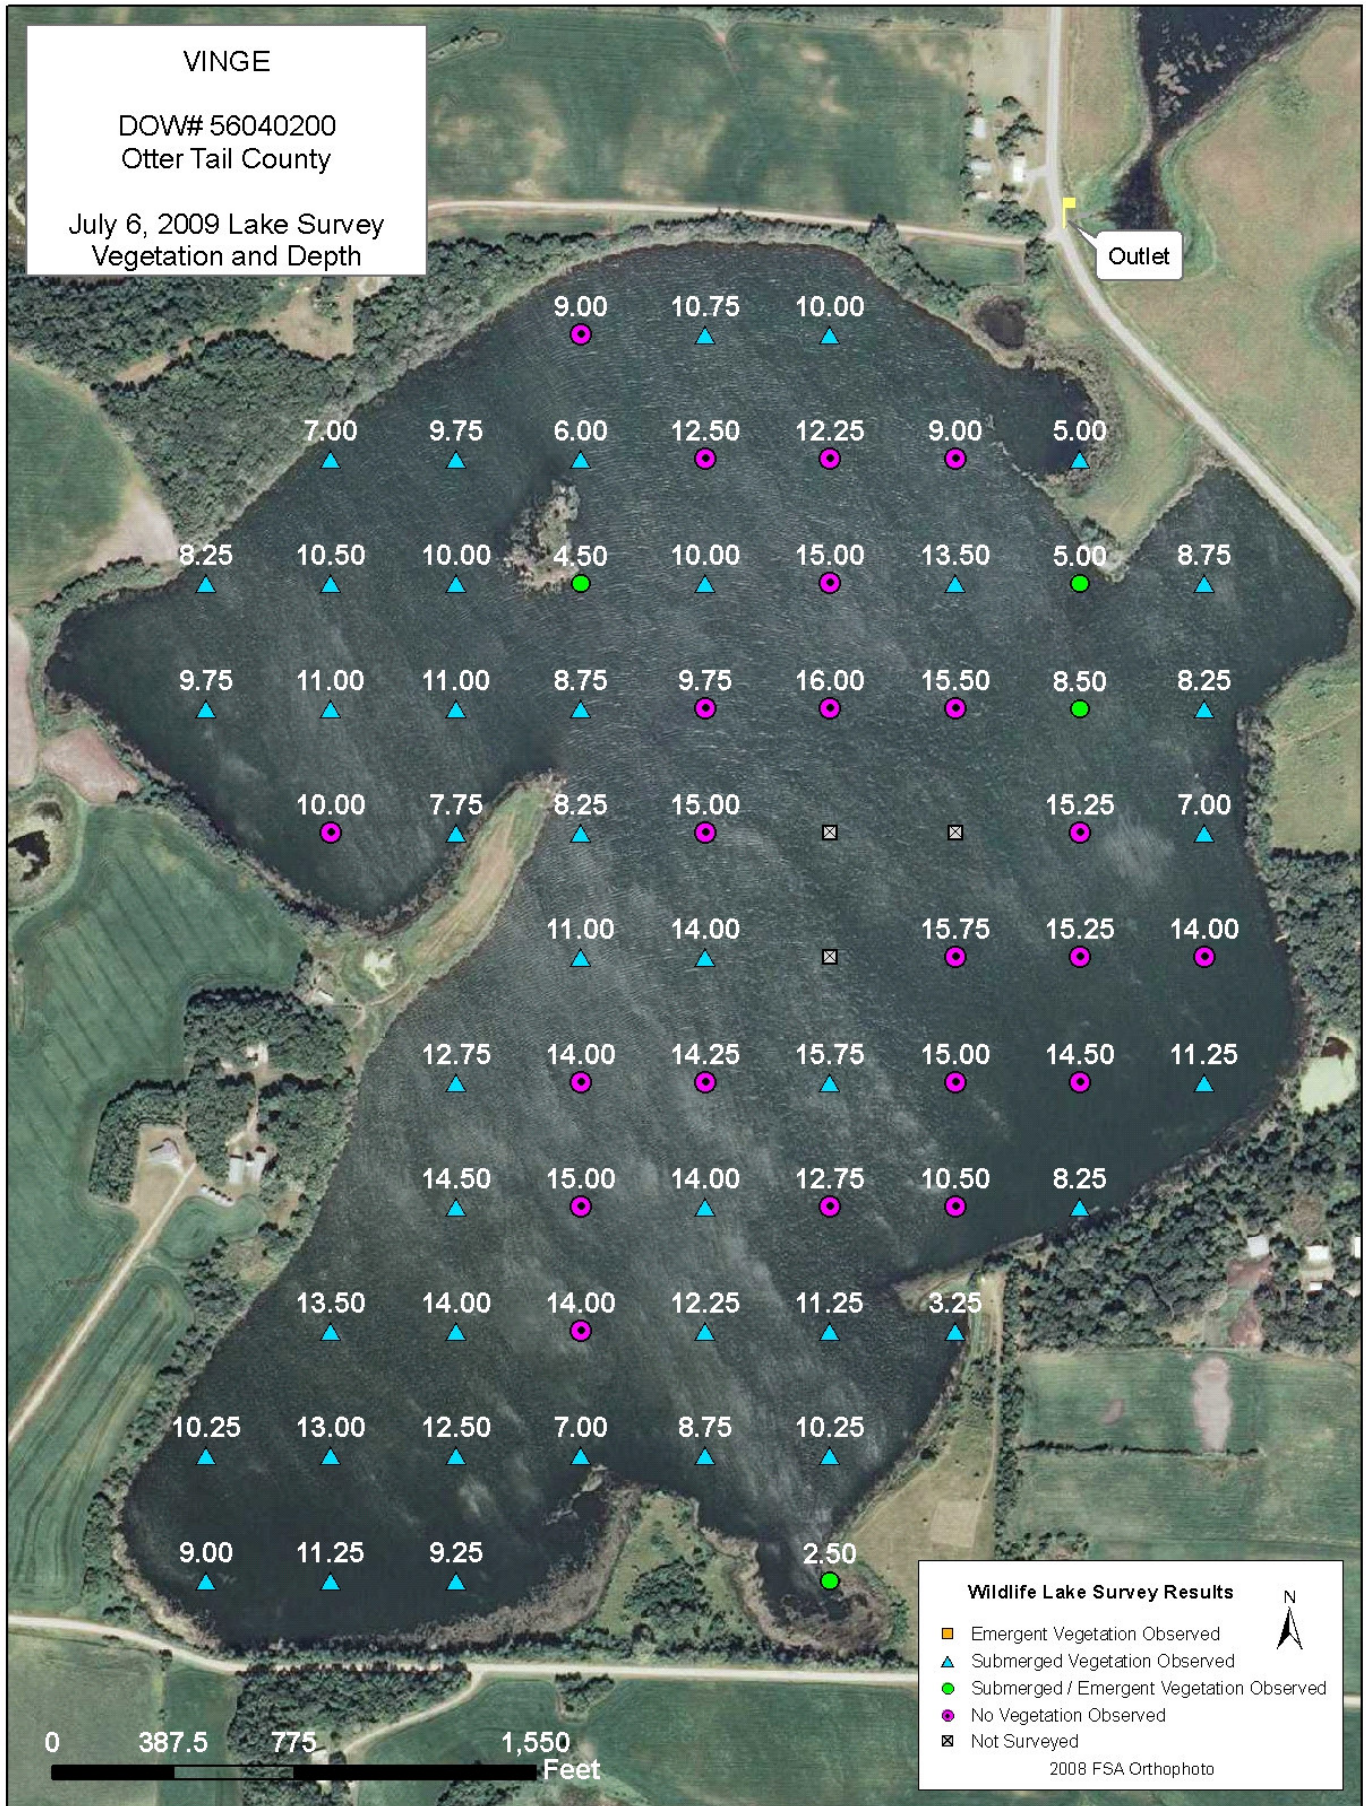
Survey Map

Minimum Depth: 2.5 Minimum Secchi: 2.5 Initial # of Stations: 71

Maximum Depth: 16.0 Maximum Secchi: 16.0 Number of Stations Sampled: 68

Mean Depth: 10.9 Mean Secchi: 10.9
