Wildlife Lake Habitat Survey Report

NAME OF LAKE: Artichoke

DATE OF SURVEY: 6/1/2009

TYPE OF SURVEY: Wildlife Lake Survey

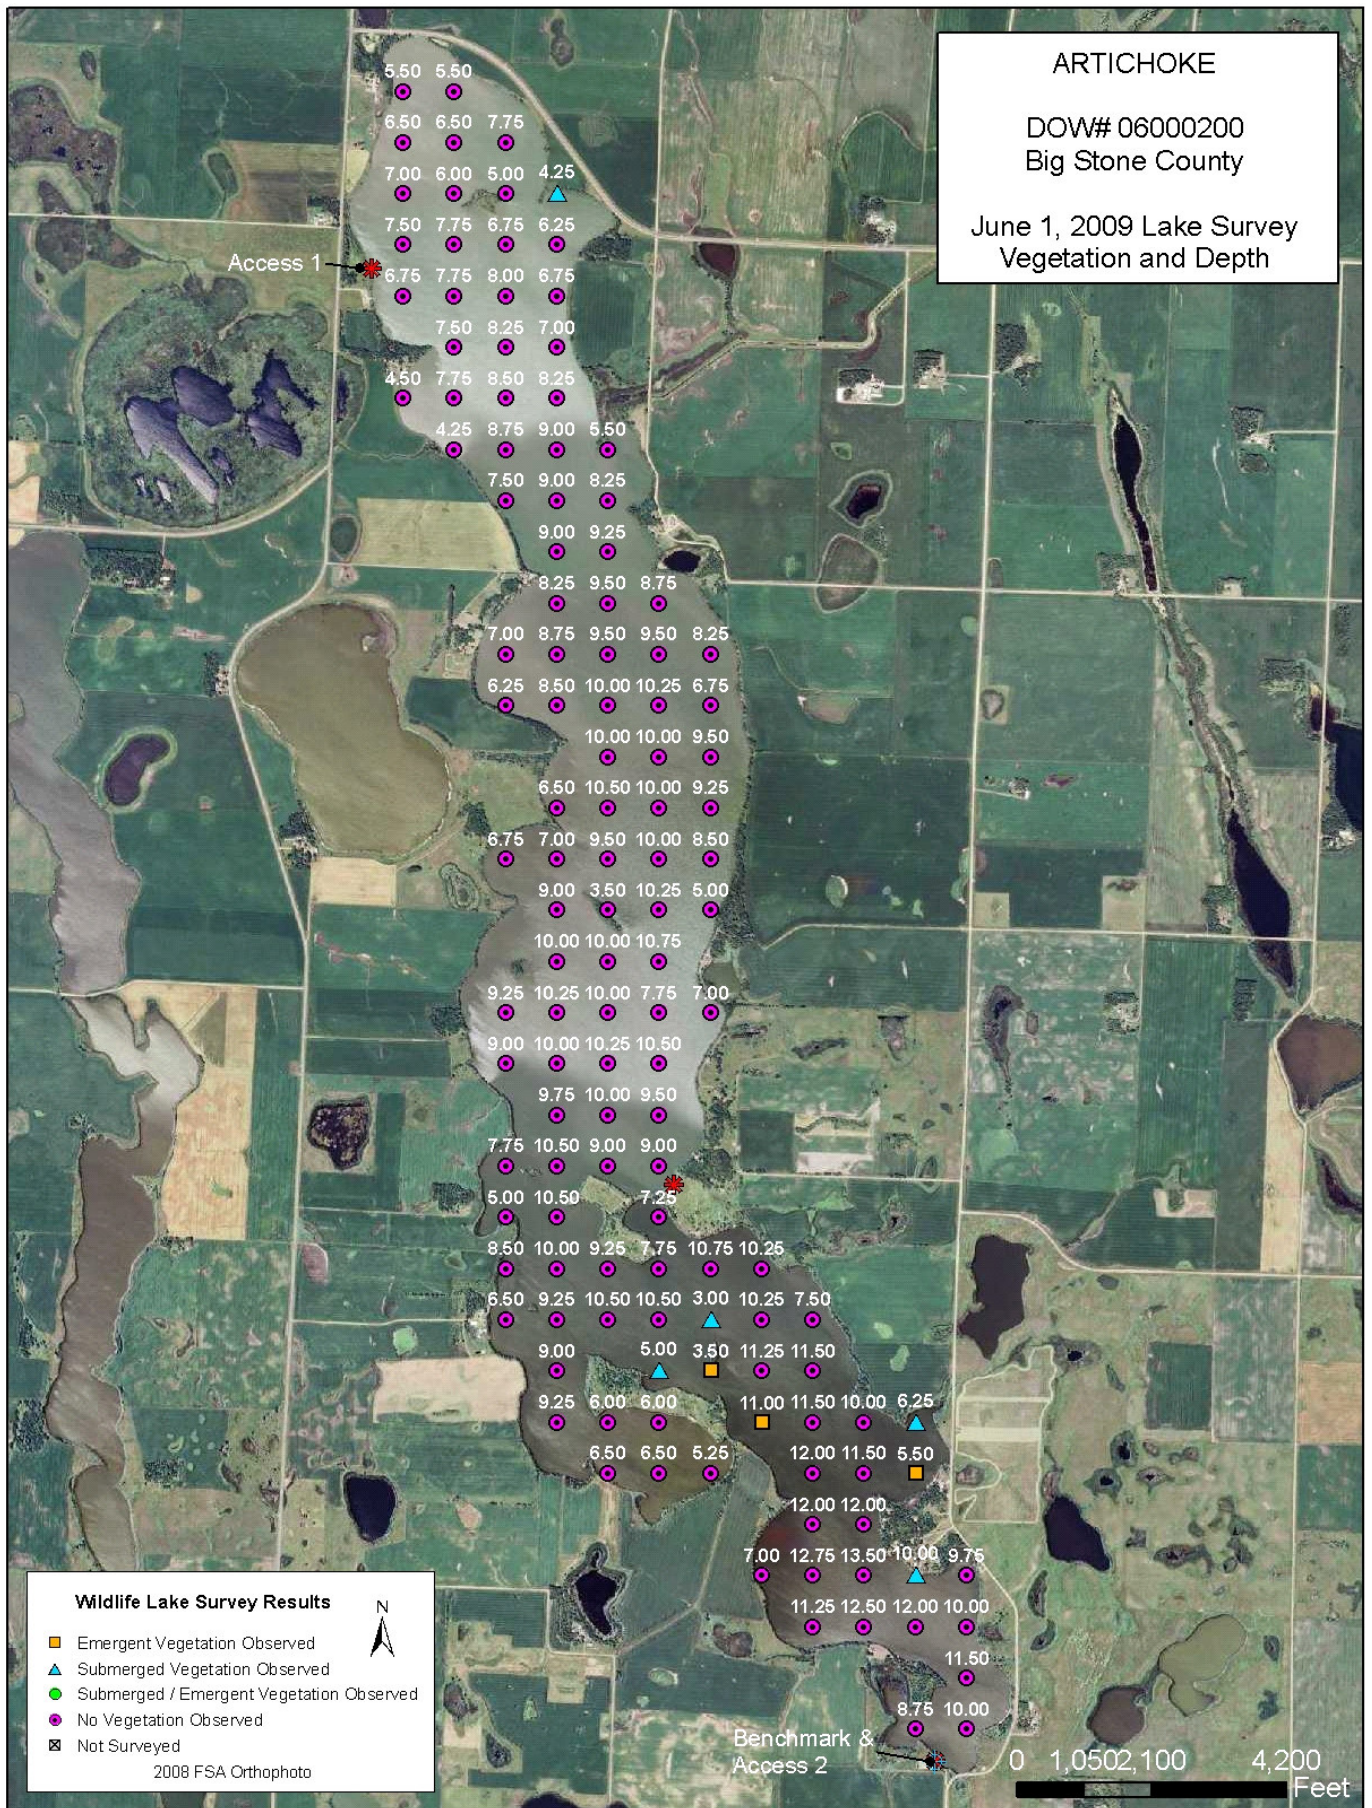
Survey Map

Minimum Depth: 3.0 Minimum Secchi: 2.3 Initial # of Stations: 129

Maximum Depth: 13.5 Maximum Secchi: 7.5 Number of Stations Sampled: 129

Number of Sample Stations: 129

Percent of Vegetated Plots: 6.2%
