Wildlife Lake Habitat Survey Report

NAME OF LAKE: South Drywood

DATE OF SURVEY: 8/12/2009

TYPE OF SURVEY: Wildlife Lake Survey

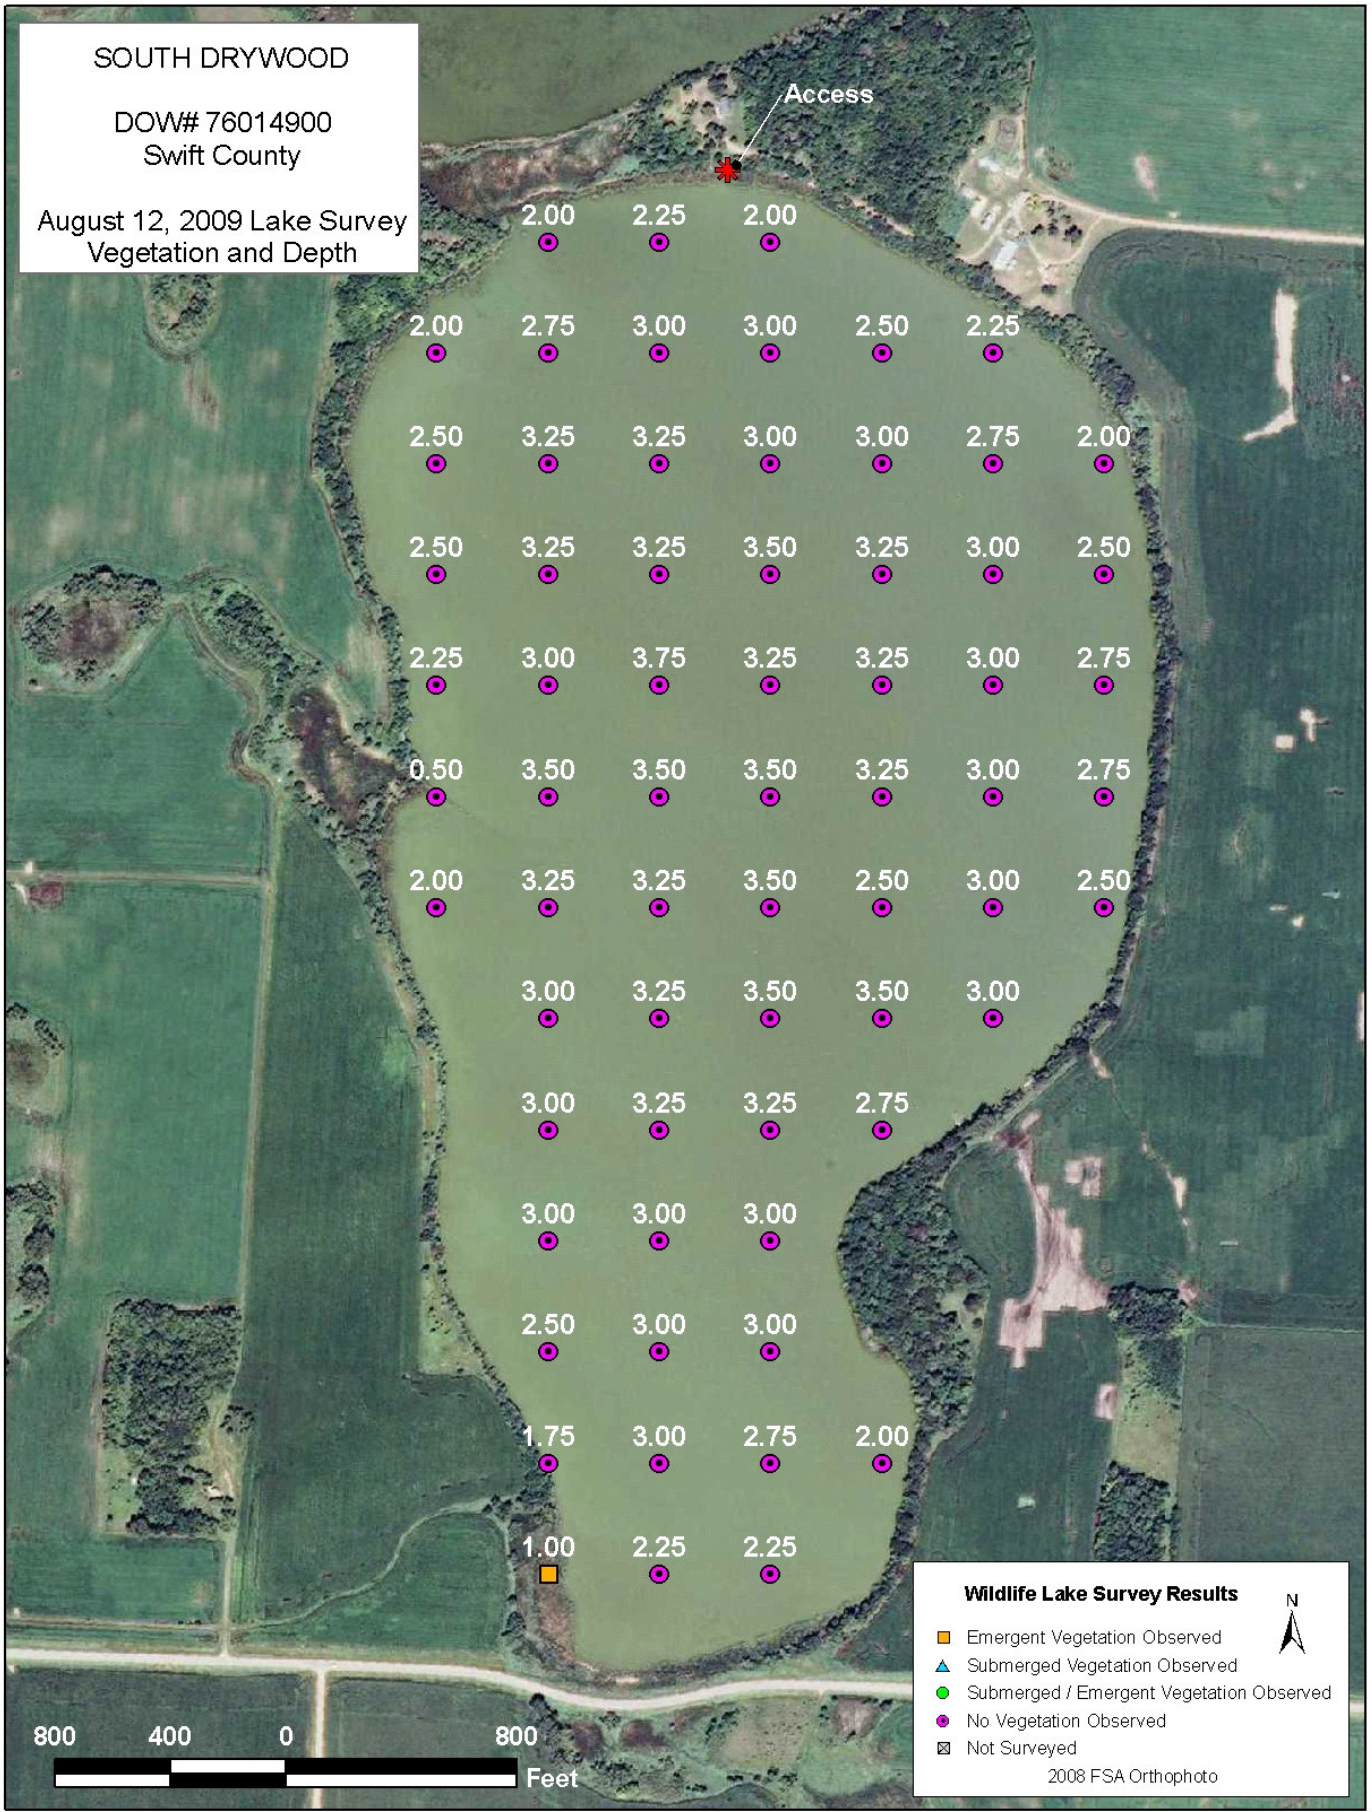
Survey Map

Minimum Depth: 0.5 Minimum Secchi: 0.3 Initial # of Stations: 66
Maximum Depth: 3.8 Maximum Secchi: 0.3 Number of Stations Sampled: 66
Mean Depth: 2.8 Mean Secchi: 0.3
